Kaaawa Flooding

Thursday, March 2, 2006

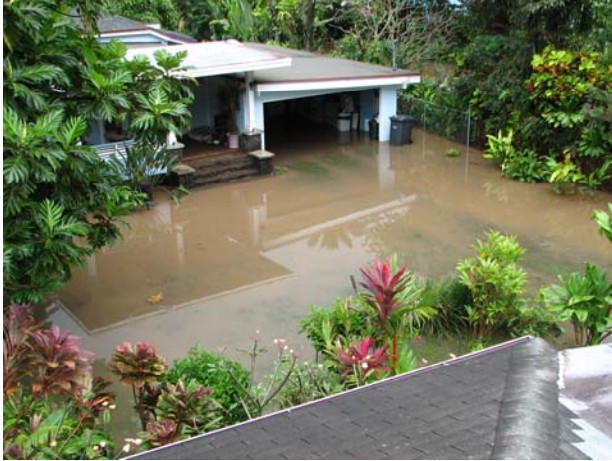
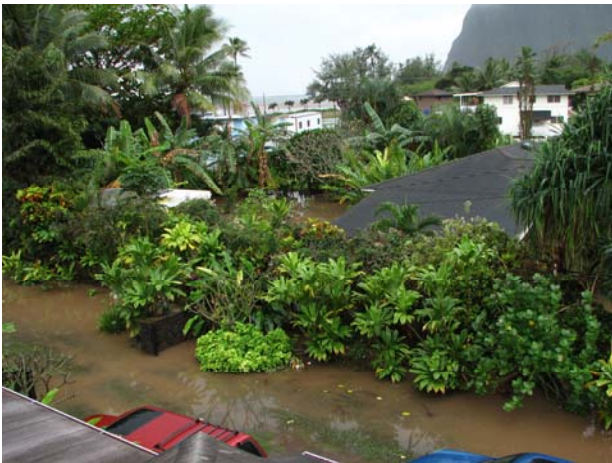
51-291 Kekio

- Photos taken before majority of flooding.
- Water level rose to above second step of porch.
- Flooding extends through neighboring lots to Kaaawa Elementary School.

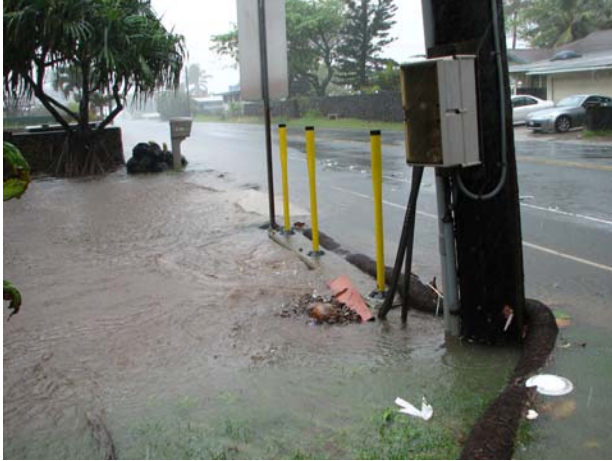
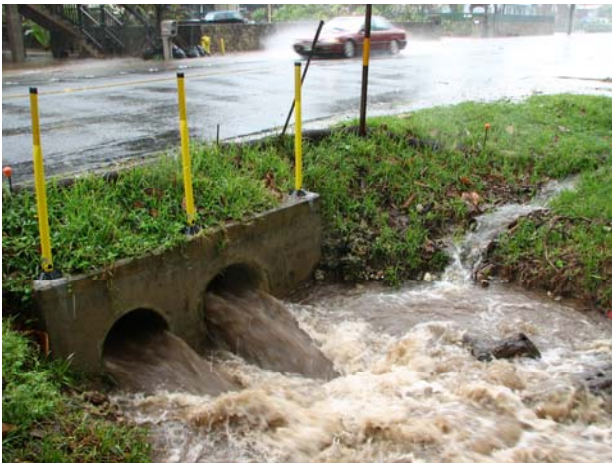
Culvert South of Ohelokai

- Culvert overwhelmed on intake side of Kam Hwy.
- Excessive discharge velocities causing scouring on makai side of highway (beach park near comfort station site).

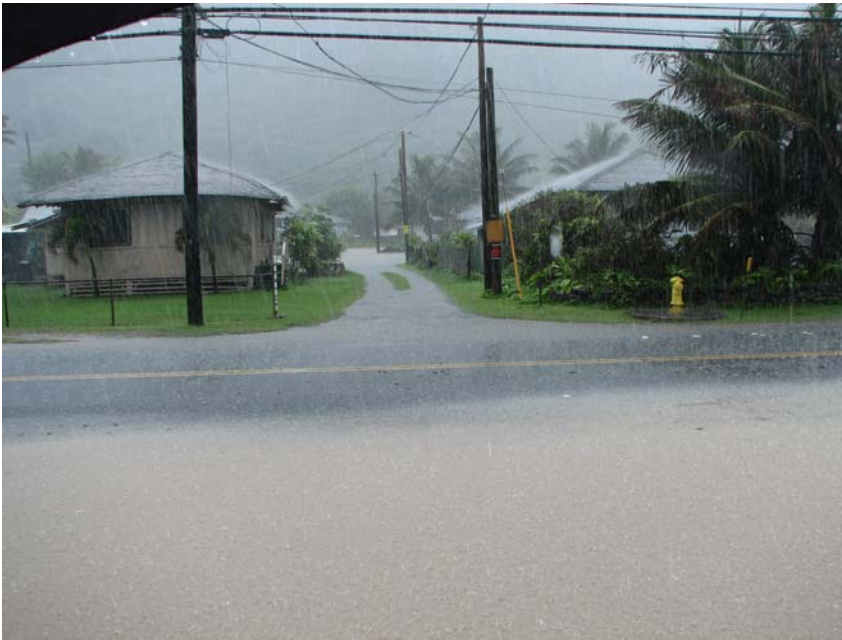
Highway Damming

- Photo looking mauka from Kaaawa Beach Park.
- Lack of culverts flooding numerous lots.

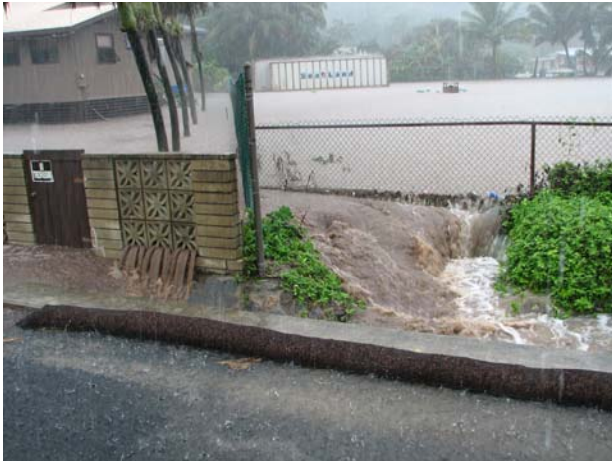
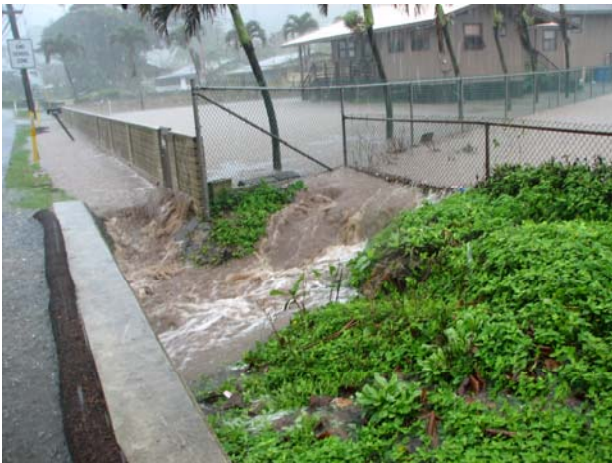
North Corner of Kaaawa Elementary School

- Fencing acting as dam, flow to culvert is impeded.
- Extensive flooding of school grounds and surrounding lots.

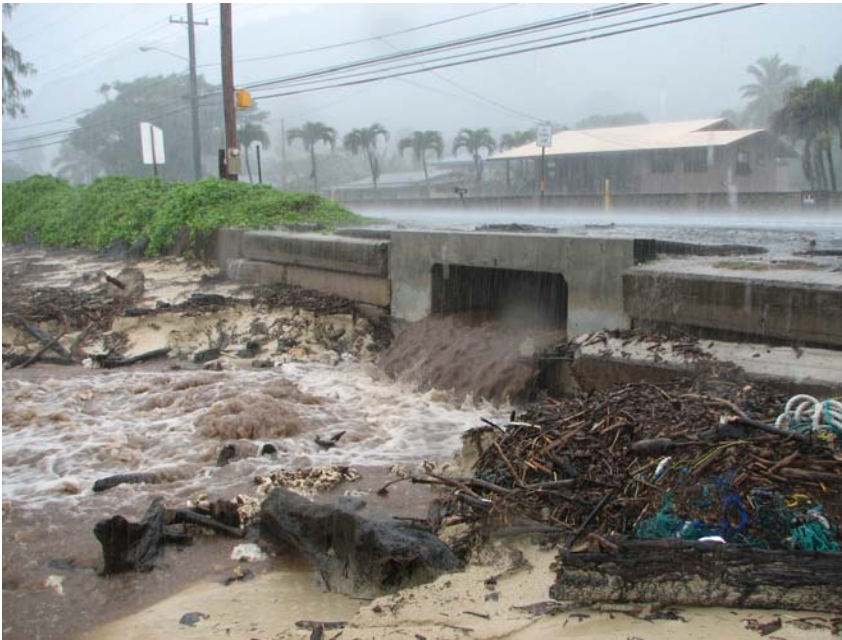
Box Culvert at North End of Kaaawa Elementary School

- Impeded Intake causing culvert to discharge below capacity.
- Inadequate surrounding structure undermining highway integrity.

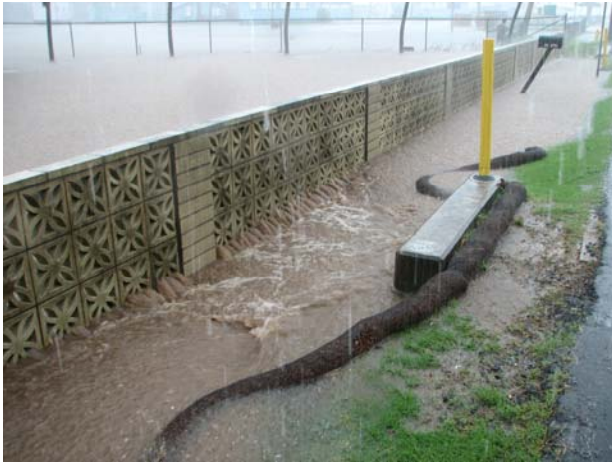
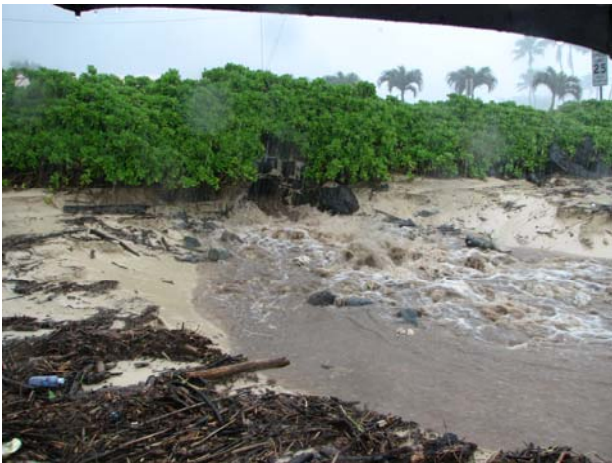
Culvert North of Kaaawa Elementary School

- Culvert intake overwhelmed.
- Excessive velocities at single undersized discharge point scouring beach.

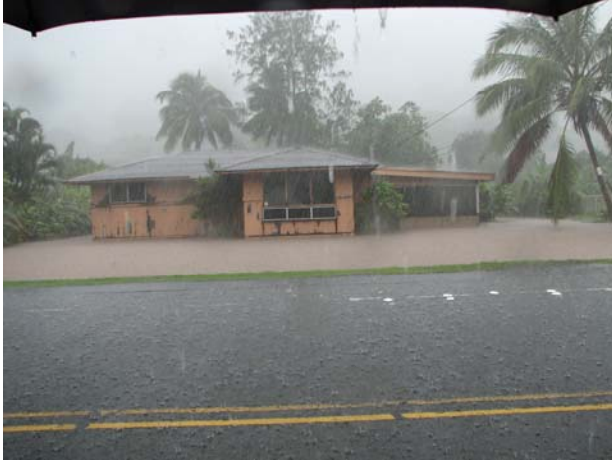
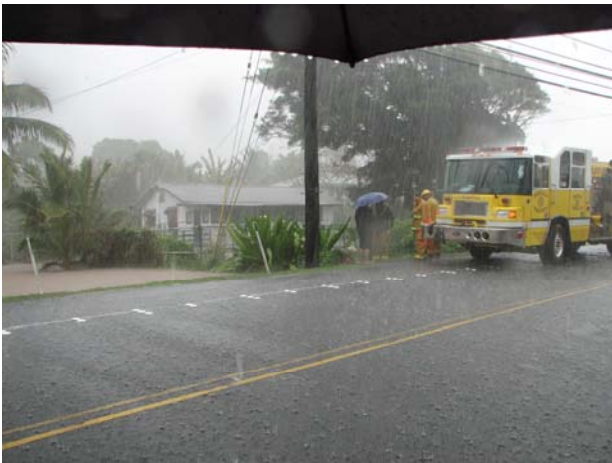
Flooded Home on Kam Hwy

- Located between elementary school and Pohuehue.
- Emergency pumping required to save structure.

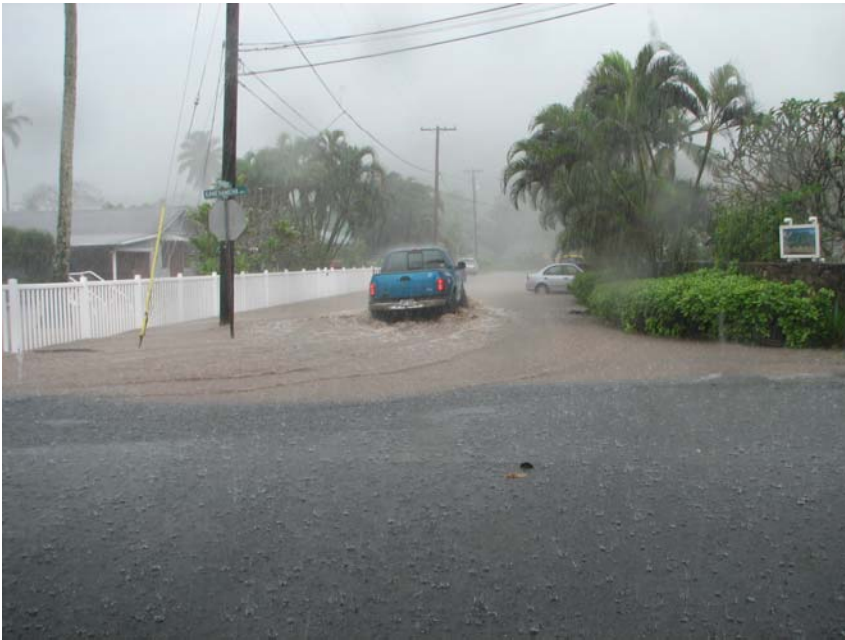
Pohuehue Street

- Street located at toe of pali “apron” (talus slope at bottom of cliff complex).

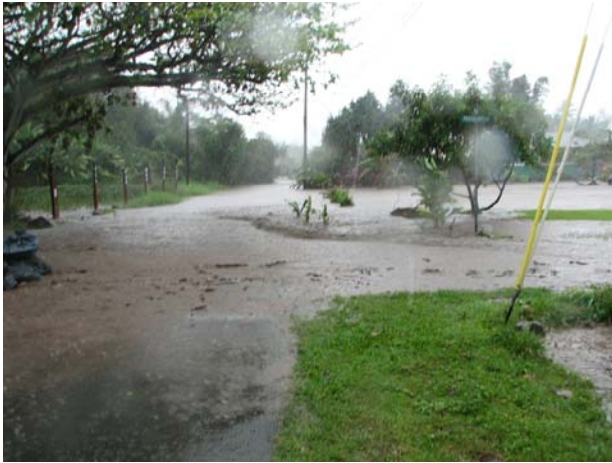
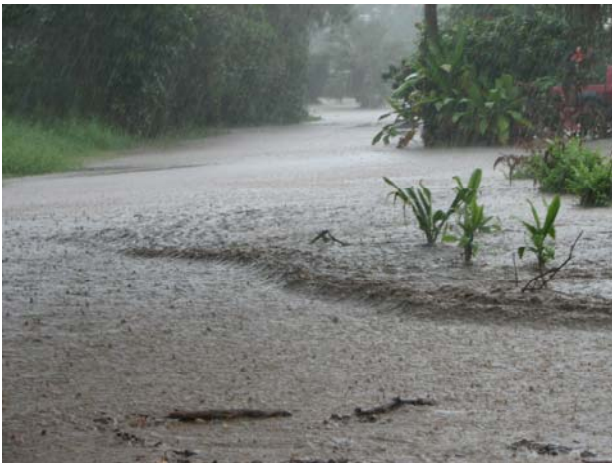
Kekio and Pohuehue

- Water streaming down from upslope.
- Sheet flow across road creating standing waves.
- Last segment of frontage trench not yet filled is submerged with no drainage outlet.

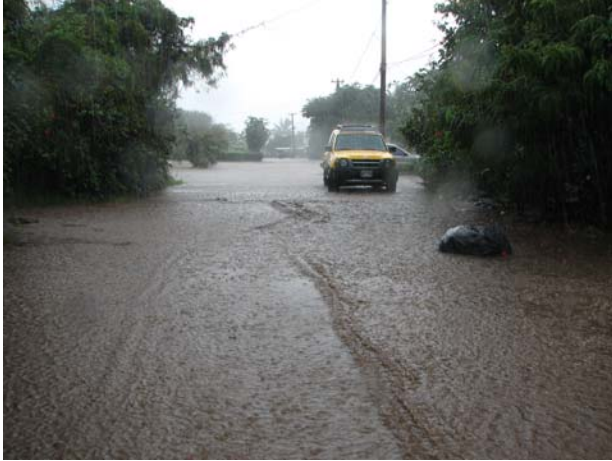
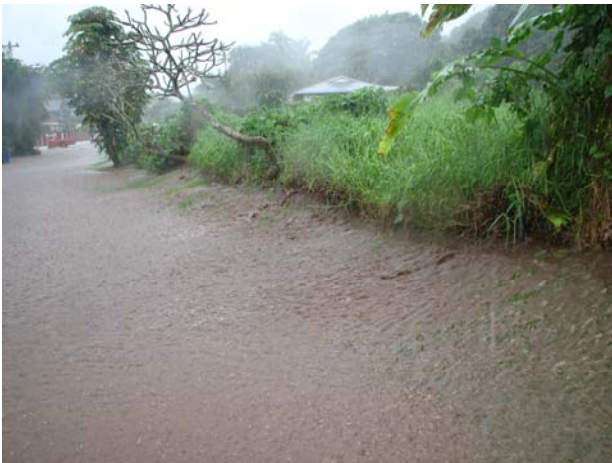
Kekio Road

- Sheet flow onto road creating standing waves.
- Water channeled down Kekio towards low point at intersection of Kekio and Ohelokai.

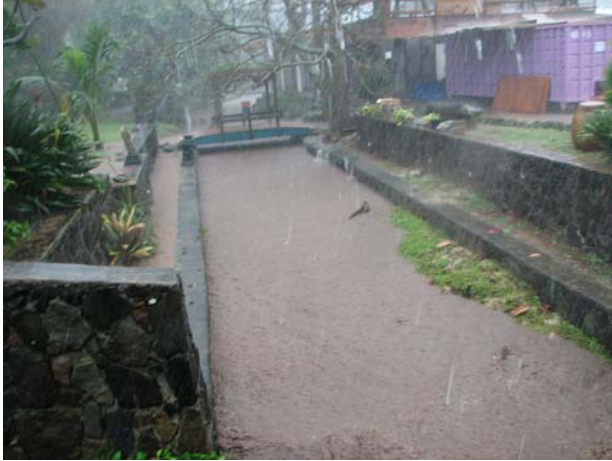
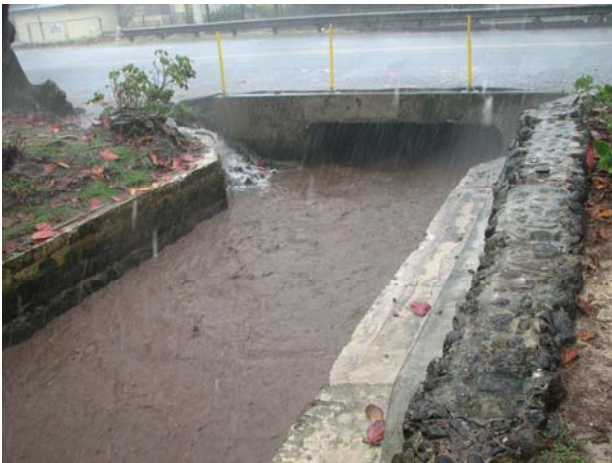
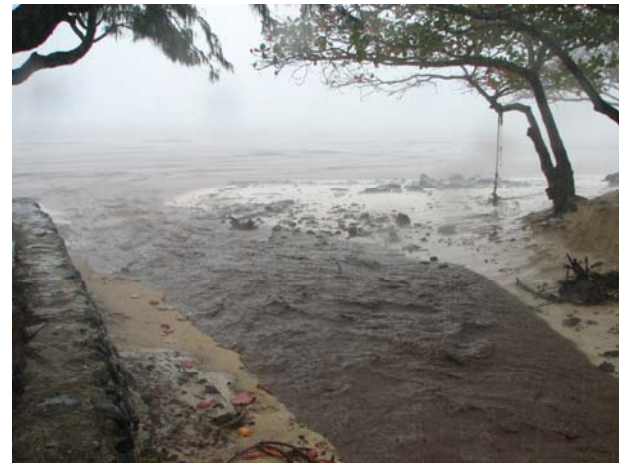
Box Culvert at Kalae Oio Beach Park

- Functioning at full capacity.

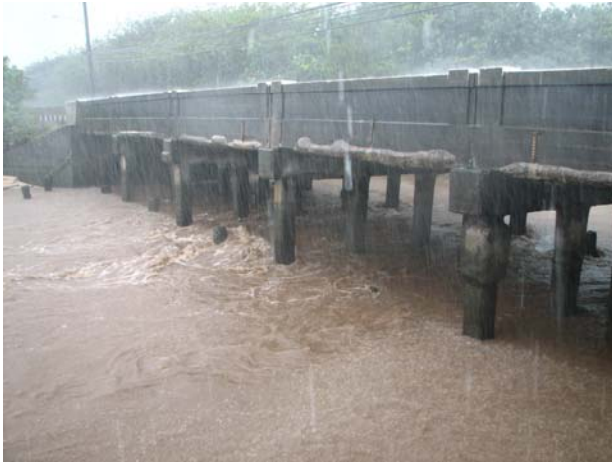
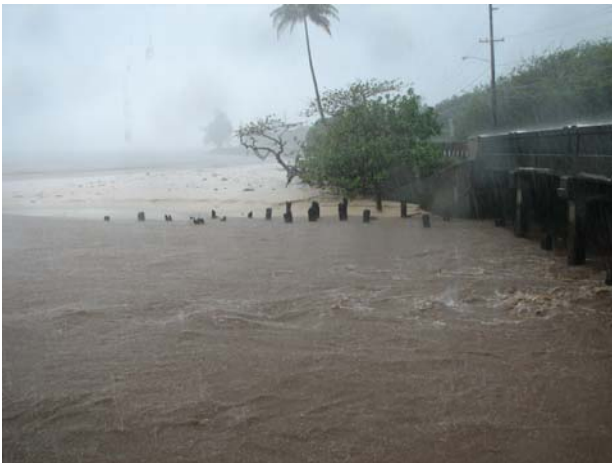
Kaaawa Bridge

- Scour revealing old pier pilings.
